**AN ASSESSMENT OF
STORMWATER MANAGEMENT
RETROFIT AND
STREAM RESTORATION
OPPORTUNITIES IN
BALLENGER CREEK WATERSHED,
FREDERICK COUNTY,
MARYLAND**

**Frederick County
Division of Public Works
118 North Market Street
Frederick, Maryland 21701-5422**

**Versar, Inc.
9200 Rumsey Road
Columbia, Maryland 21045**

August 2005

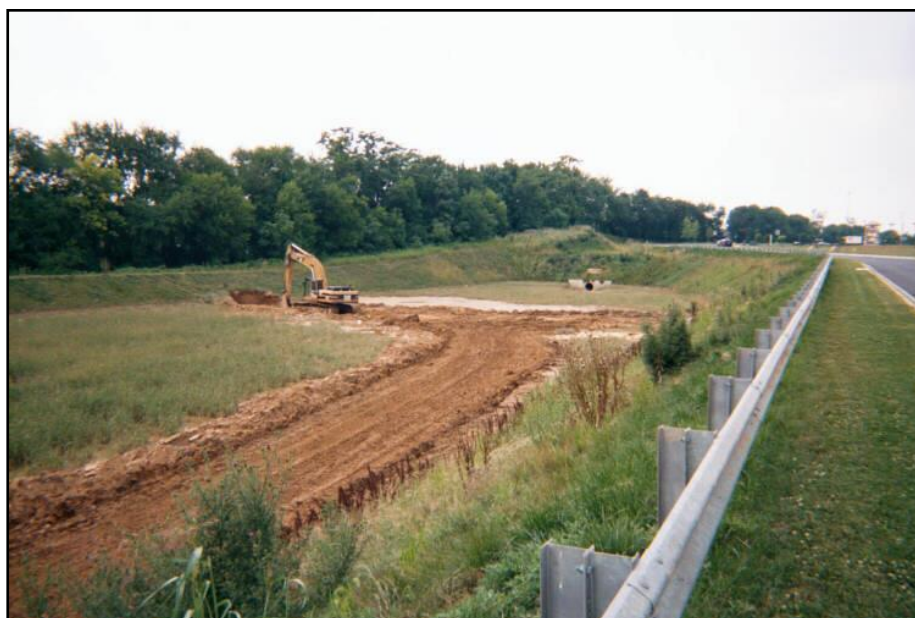
Figure 1-2. Sinkhole repair in the bottom of a stormwater management facility, Gilford Road across from Wal-Mart, July 2000.

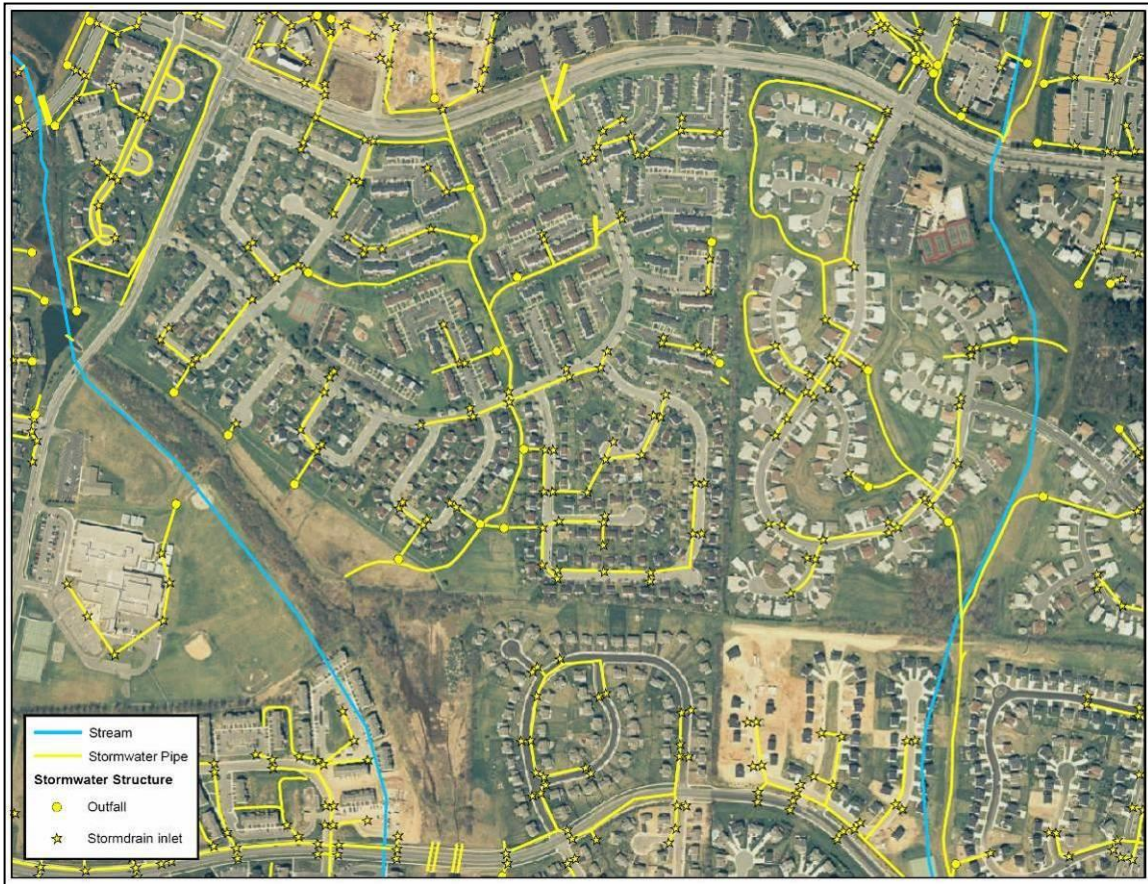
Figure 2-3. Example of orthophotography (March 2000) and stormwater conveyance features used in conjunction with other GIS data (see Figure 2-2) to help identify potential stormwater retrofit and stream restoration opportunities in Ballenger Creek watershed. This image shows the area located in the center of Figure 2-2.

(completed in 2004) and printed as a 70-page indexed map book at a scale sufficient to view conditions on the ground (Figure 2-3).

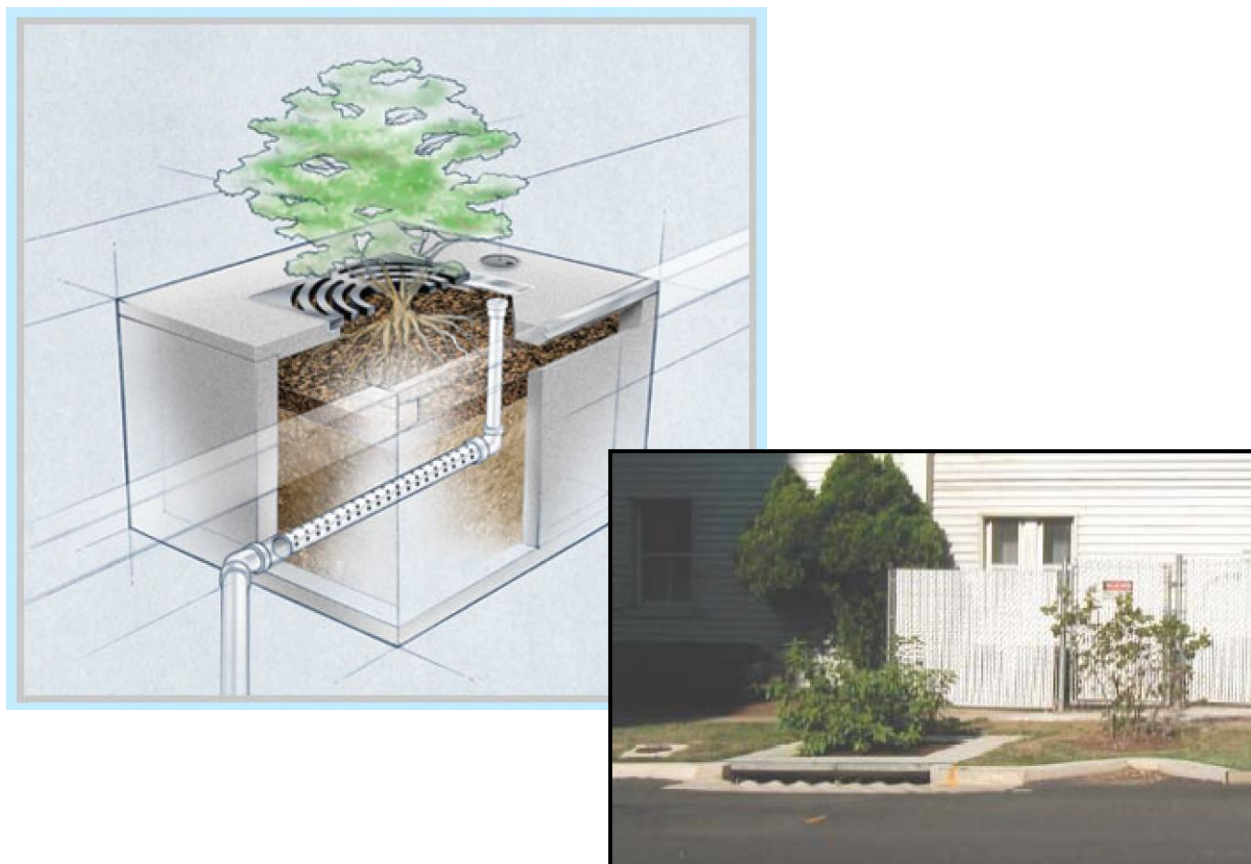
Figure 3-8. Manufactured LID Device – Filterra® tree box insert in storm drain inlet
(Source: VA DCR 2002 and filterra.com)

Maintenance: Debris and sediment removal, replacing dead or stressed plants, and mulching as necessary are the primary maintenance considerations. Most manufactured LID devices come with an observation well that is used to make sure the underdrain is not clogged and is working properly. If the system becomes clogged, the filter mixture is replaced. Additionally, most manufacturers have their own maintenance guidelines that need to be followed to maintain the performance level. Manufactured LID devices have an expected life span of 25 years.

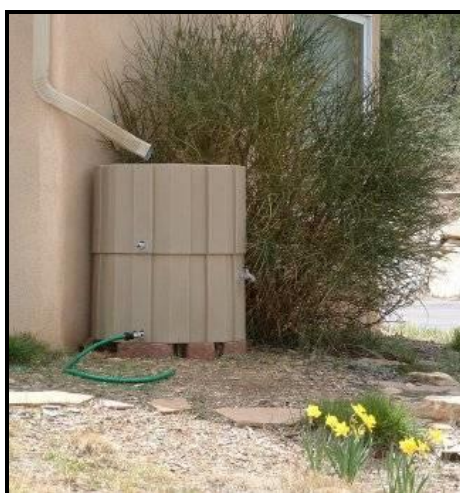
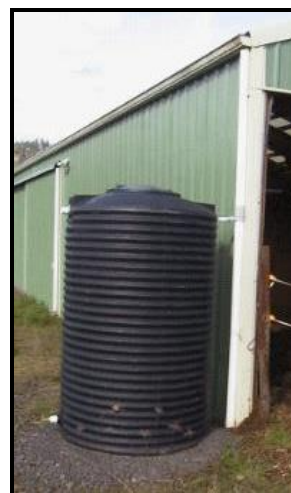
Figure 3-9. Rain barrel & above-ground cistern

Maintenance: Rain barrels and cisterns require very little maintenance. The container and attachments should be inspected for clogging several times a year and after significant storm events. Minor parts, including spigots, screens, filters, downspouts, or leaders, may require replacement. Rain barrels and cisterns have an expected life span of 25 years.

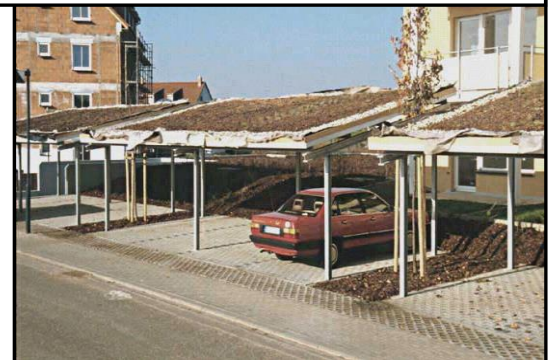
Figure 3-10. Carport with green roof
(Source: Prince Georges's County 1999)

Maintenance: Once a green roof is well established, its maintenance requirements are usually minimal. Initial watering and occasional fertilization are required until the plants have fully established themselves, and periodically thereafter during drought conditions. Periodic trimming, weeding, inspection, and plant replacement is necessary.

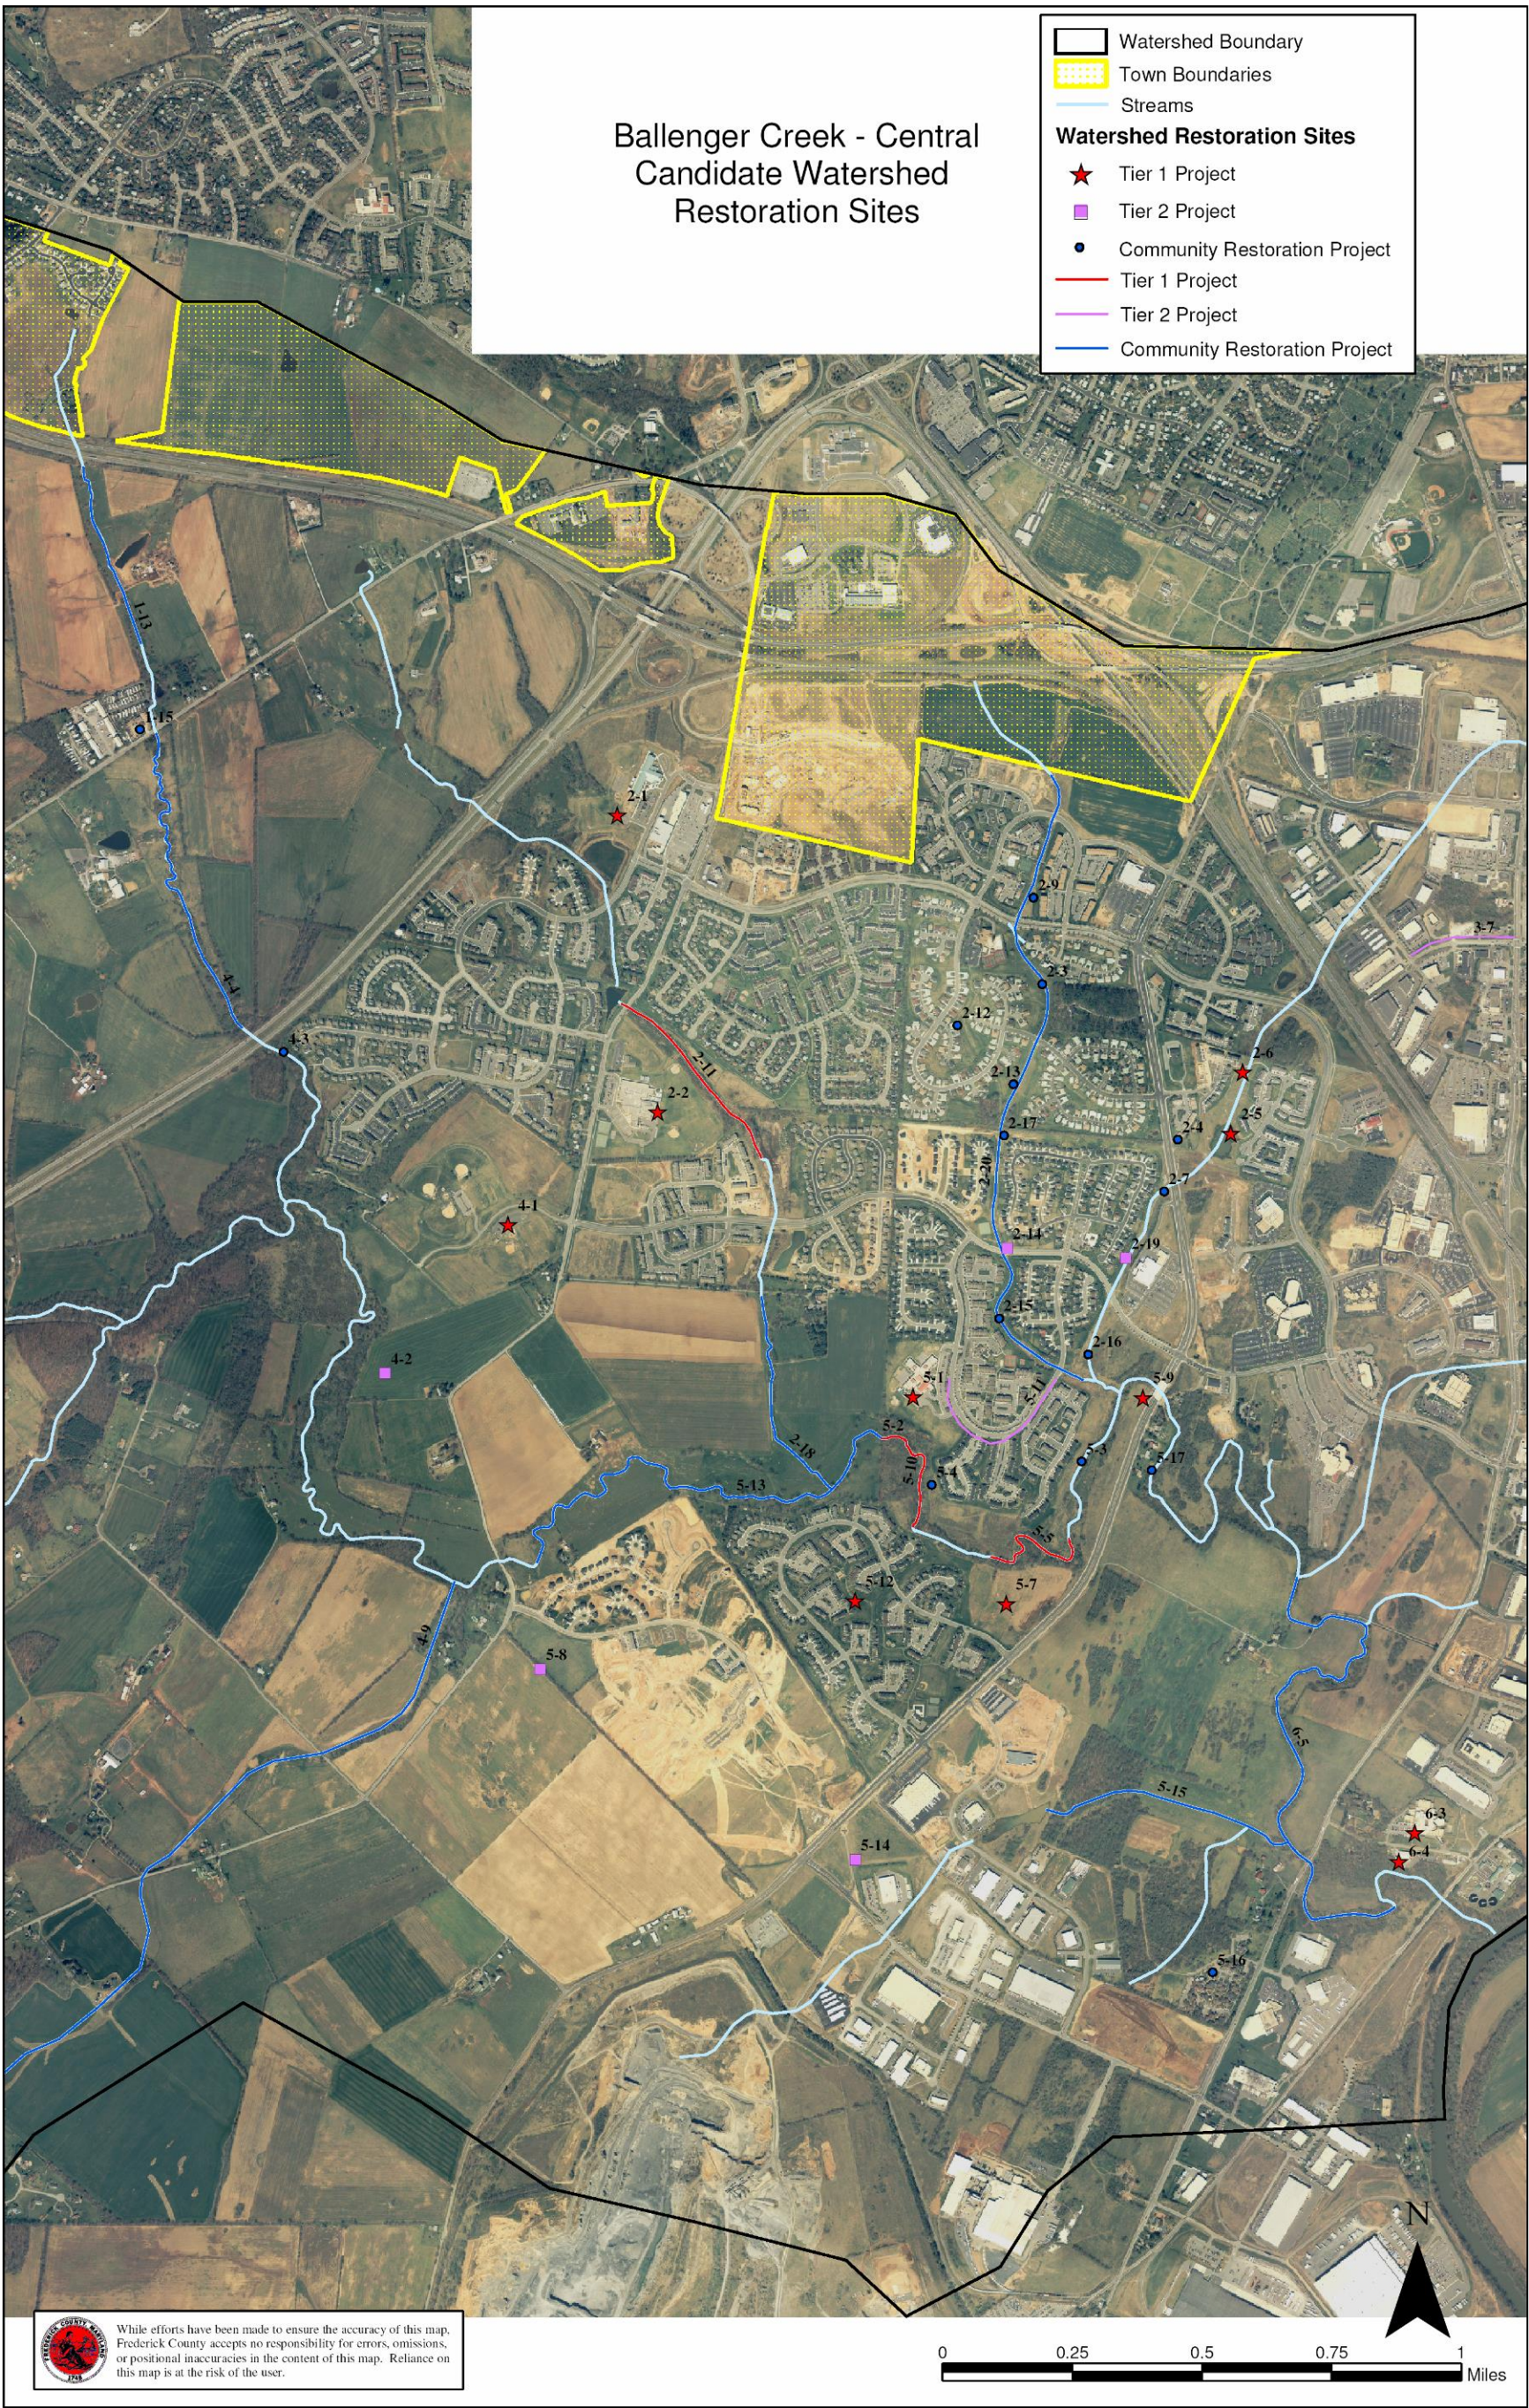
Figure 4-2. Candidate watershed restoration sites identified in Central Ballenger Creek Watershed, Frederick County, MD

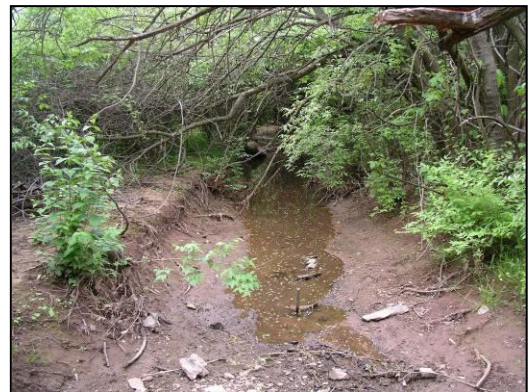
Pike Branch: reduced base flow and invasive species

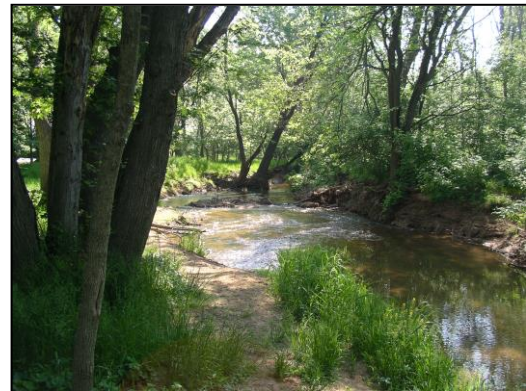
Eroded banks and narrow buffer

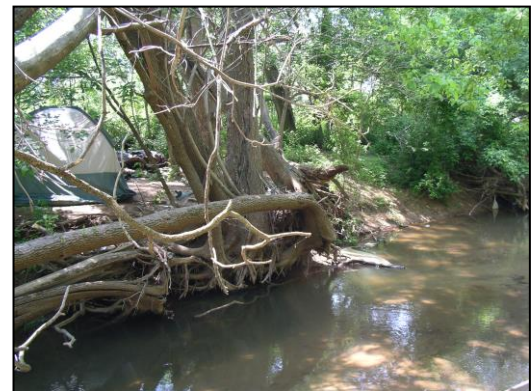
Undercut trees

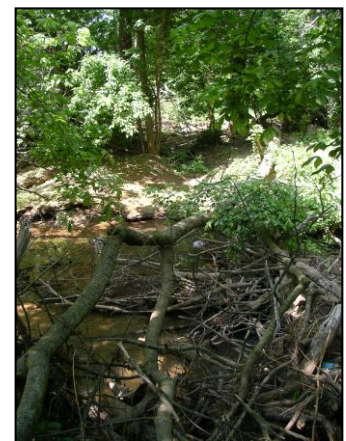
Cutoff and debris jam

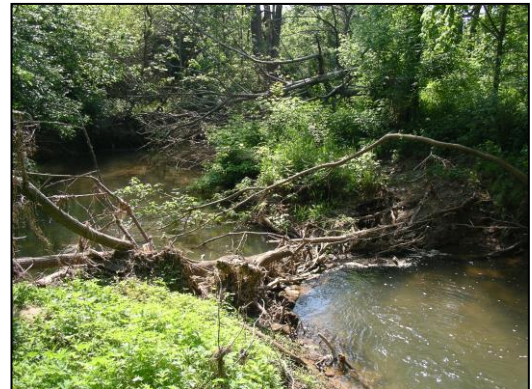
Debris jam and eroded banks

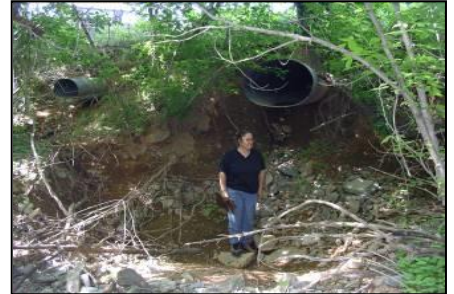
Proposed location for culvert replacements and repair of scour hole
